# Flexible, Peelable Encapsulating Membrane for Corrosion Protection

# 3411

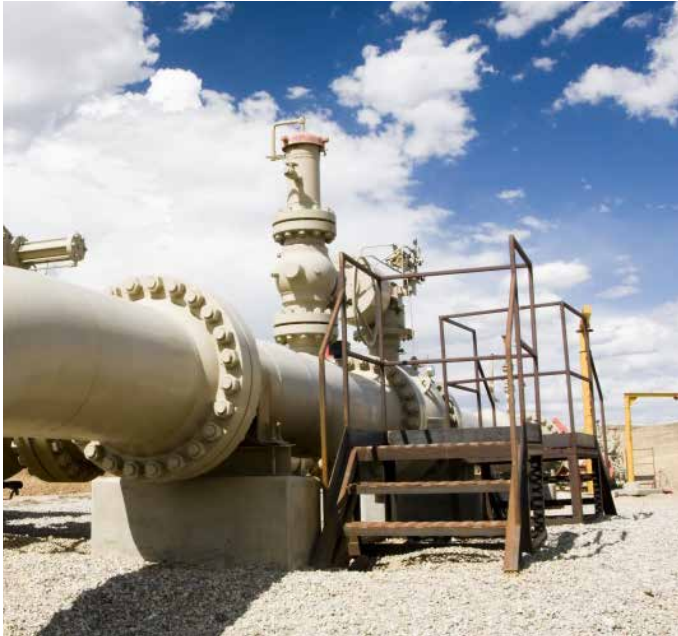
Belzona 3411 is a solvent-free hybrid polymer coating which is used to completely encapsulate substrates with complex geometries, such as flanges.

When encapsulated, flanges are then protected from the elements. Moisture is excluded from the substrate and corrosion is prevented.
